TECHNICAL NOTICE

BURNER MANIFOLD SEALING GASKETS

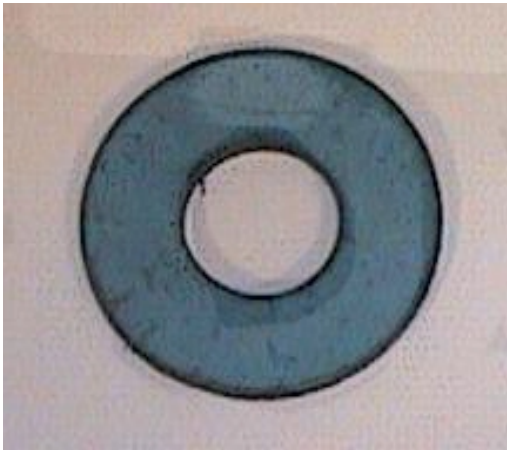
Fibre washer

The fibre washer used to seal the burner pipe onto the burner manifold has sometimes failed to reseal when the manifold position is adjusted at the end of the forehearth warm-up.

In a move to improve combustion equipment reliability BH-F will supply new viton gaskets in place of fibre washers on all new orders.

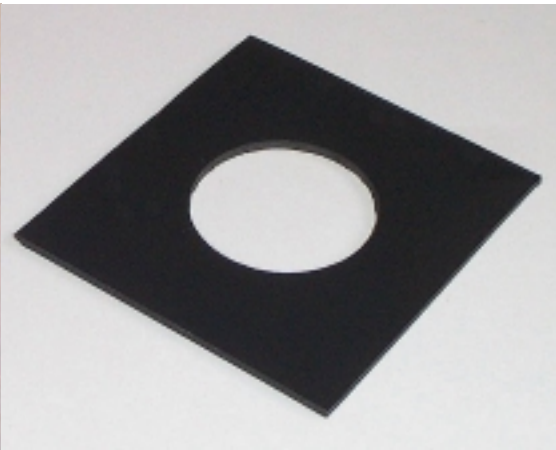
New Gasket.

The new viton material has been tested to ensure that, even after exposure to high temperatures, the gasket reseals successfully. During these tests it was found that much less clamping force is required to achieve a good seal.
